## **Village of Hoffman Estates**

Fire Station No. 21 & No. 22 Station Location Analysis, Facility Analysis and Conceptual Design Study

June 1, 2023

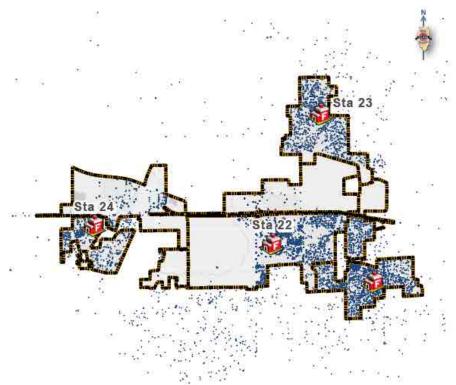
Figure 1: Pg. 32 of the Addendum

20,700
TOTAL INCIDENTS
19,104
TRA INCIDENTS
1,596
OUTSIDE TRA INCIDENTS

The IFCA Team analyzed 20,700 incidents from January 2019 through June 2022. The Team identified 19,104 incidents within the Total Response Area (TRA) of the HEFD. EMS-related incidents represented 76.01% of the volume within the HEFD TRA, while 1.14% were classified as fire responses. Other incident types represent the remainder. The analysis also provided insight into the call volume and incident types outside the TRA. There were 1,596 incidents (8.35%) outside the TRA within the study period.

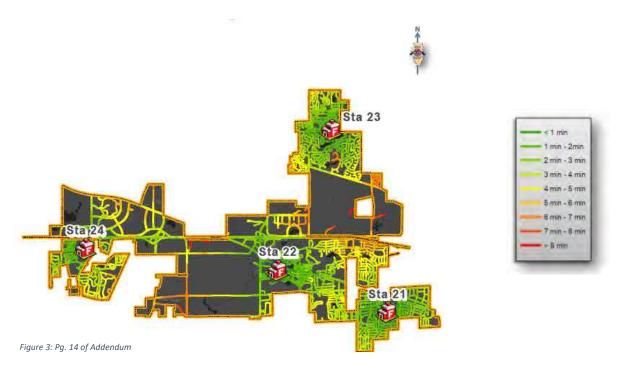
Hoffman Estates Fire Department has over 266.4 linear miles of streets within the TRA, and 188 of those linear miles can be reached within a NFPA-recommended 4-minute catchment, which equates to 71% of the TRA.

Of all the incidents HEFD responds to within the TRA, 84% of its calls for service are located within a four-minute catchment (indicated in blue) of the fire stations (calculated based on speed limits of the streets). HEFD's experience consists of arrivals on scenes within 4 minutes, 74% of the time for fire incidents, and 82% for EMS within the 4-minute catchments. Actual arrivals for the entire TRA are 63% of the time for fire incidents and 73% for EMS incidents.

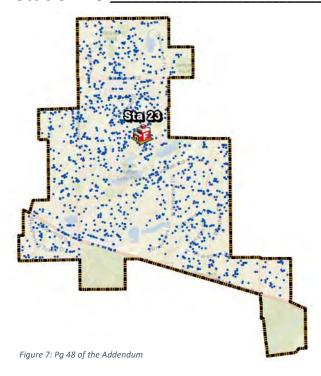
Station 23 has an Area of Responsibility (AOR) of 3.0 square miles covering a population of 13,474, totaling 4,618 households. Station 23 responded to 2,145 incidents within its AOR, which equates to 11% of the total calls within the study period. HEFD Station 23 has over 51.2 linear miles of streets within its response area, and 39.6 of those linear miles can be reached within a 4-minute catchment equaling 77% of its AOR.

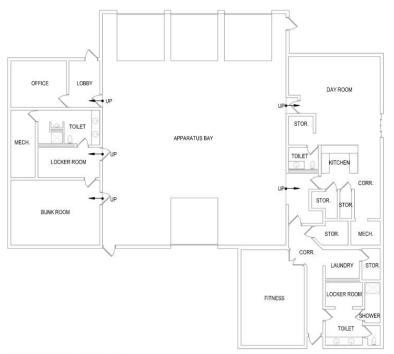
MAIN LEVEL FLOOR PLAN SCALE: 1/16" = 1' -0"

Ground Floor Gross Area: 6,175 sq.ft.

Ground Floor Net Area: 5,472 sq.ft.

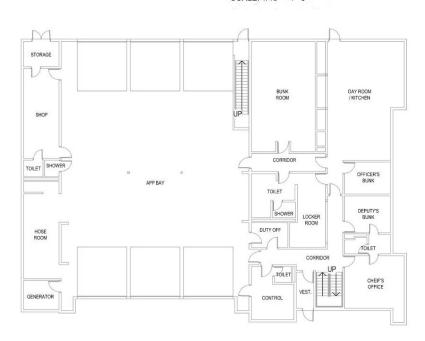
First Floor Gross Area: 8,116 sq.ft.

First Floor Net Area: 7,493 sq.ft.

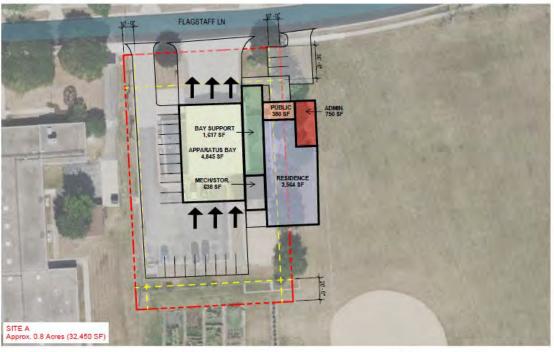
SITE PLAN DIAGRAM A

#### HOFFMAN ESTATES FD STATION 21

225 FLAGSTAFF LN, HOFFMAN ESTATES, IL 60169

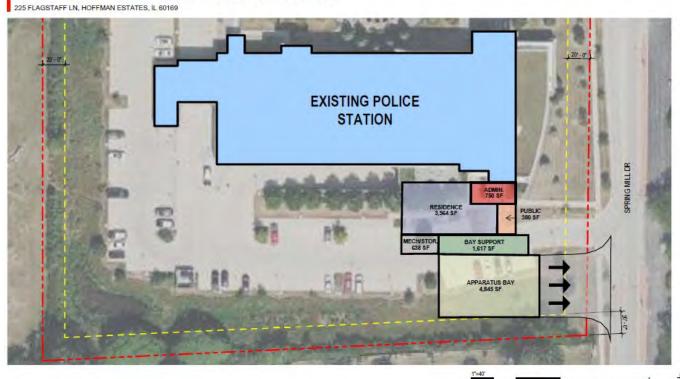
SITE PLAN DIAGRAM B

### HOFFMAN ESTATES FD STATION 21

Based on the discussion above, this solution is not a preferred option.

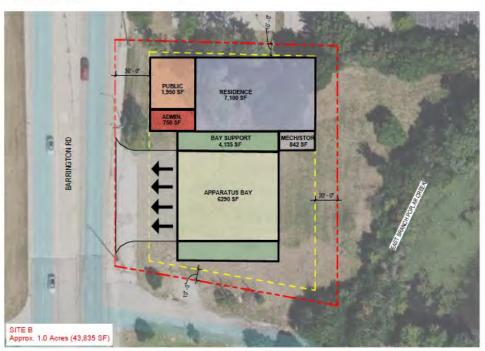
SITE PLAN DIAGRAM B

### **HOFFMAN ESTATES FD STATION 22**

1700 MOON LAKE BLVD., HOFFMAN ESTATES, IL 60169

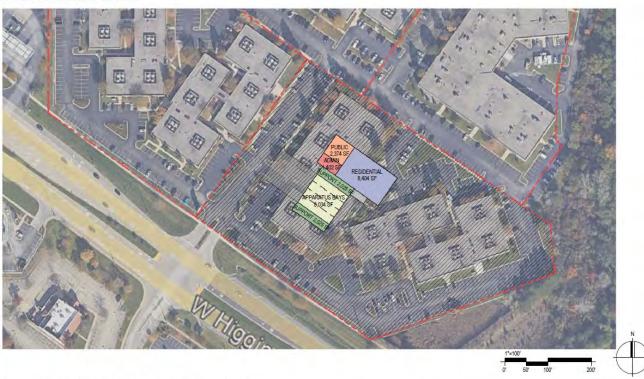
SITE PLAN DIAGRAM C

#### HOFFMAN ESTATES FD STATION 22

One potential drawback to this location is that there is some risk involved exiting onto Higgins Rd.

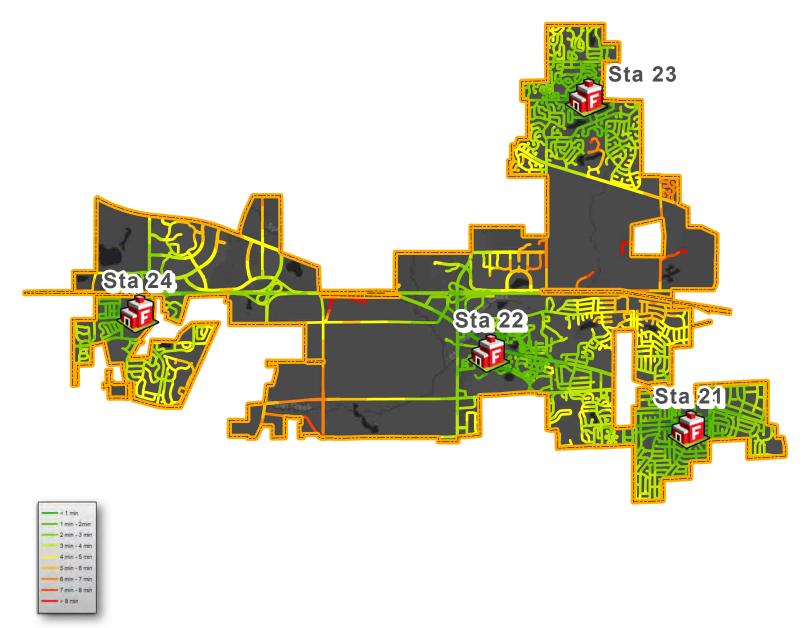
Street travel time is the time of travel from the fire stations and is displayed in one-minute increments.

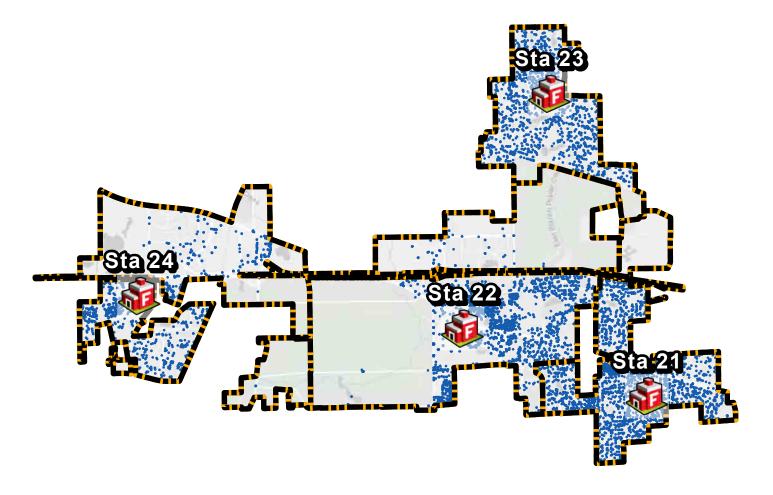
Incident Classes:
Fire: All NFIRS group 100
EMS: All NFIRS group 300
Other: All NFIRS groups excluding groups 100 and 300

2019	2020	2021	2022
Д	All Incidents	5,421	5,061	5,835	2,787
	Fire	77	65	77	37
**	EMS	4,074	3,828	4,490	2,129
lack	Other	1,270	1,168	1,268	621

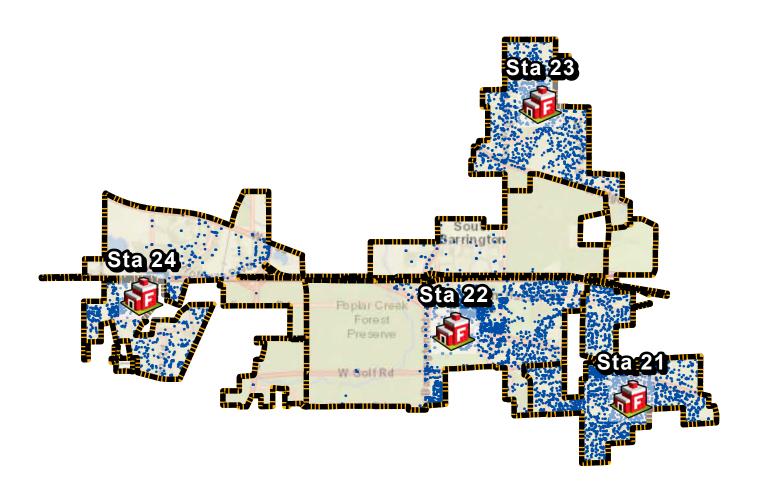
# **NFIRS Groups: Counts and Percentages**

100	200	300	400	500	600	700	800	900
1.3%	0.1%	76.1%	2.5%	5.8%	3%	11.2%	<0.1%	<0.1%
256	22	14,521	478	1,100	568	2,135	3	7

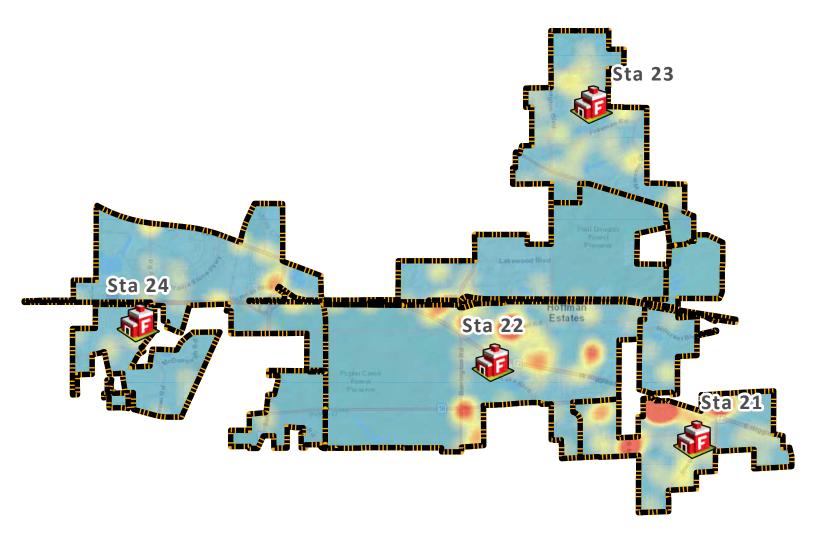
NFIRS 100: Fire

**Percentage of TRA incidents**

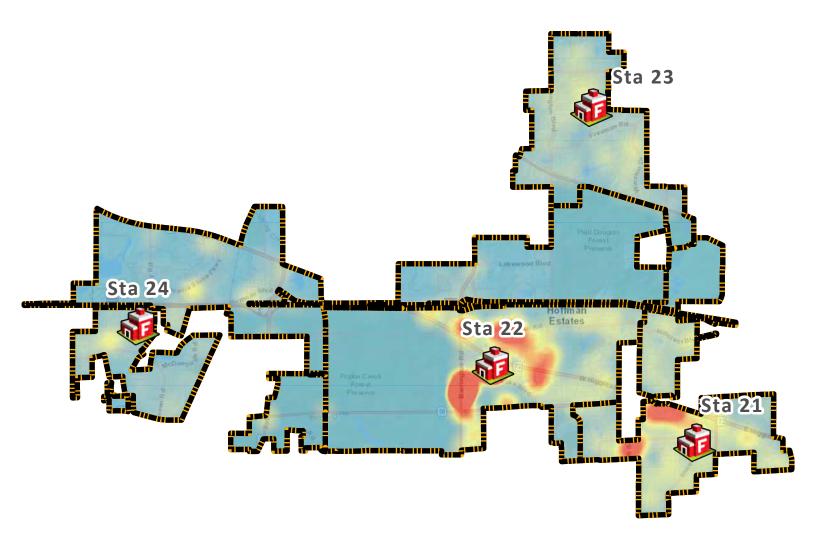
NFIRS 300: Rescue EMS

**Percentage of TRA incidents**

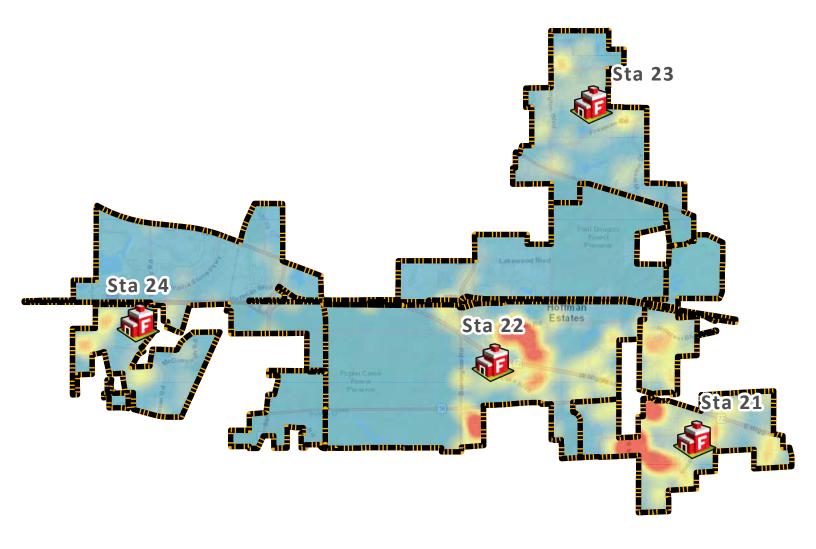
**NFIRS 400: Hazardous Condition No Fire**

**Percentage of TRA incidents**

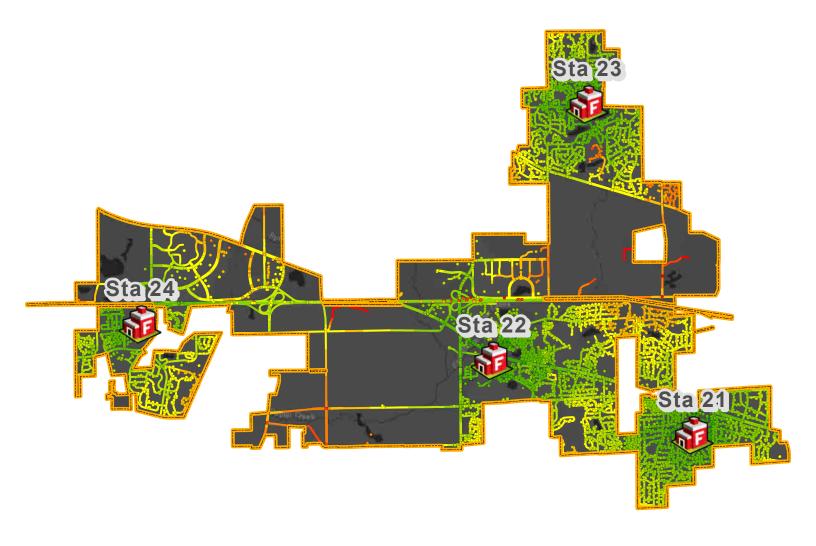
Incidents and streets are displayed in one-minute increments based on travel time from the closest fire station.

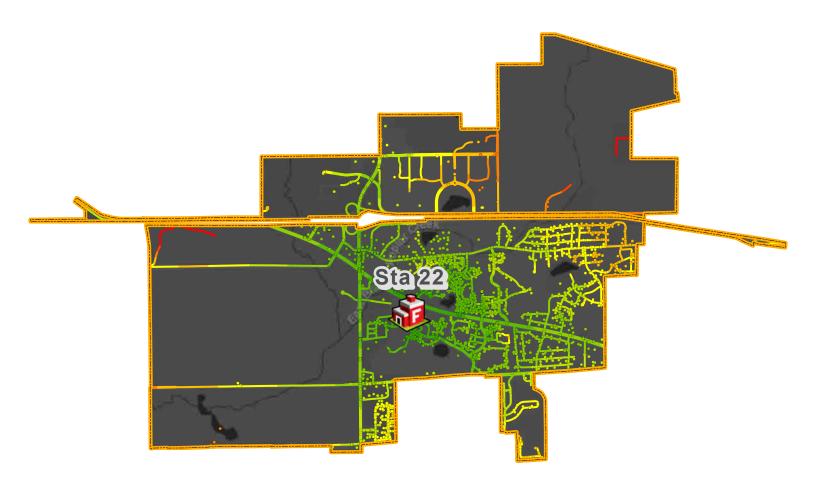
Incidents and streets are displayed in one-minute increments based on travel time from the closest fire station.

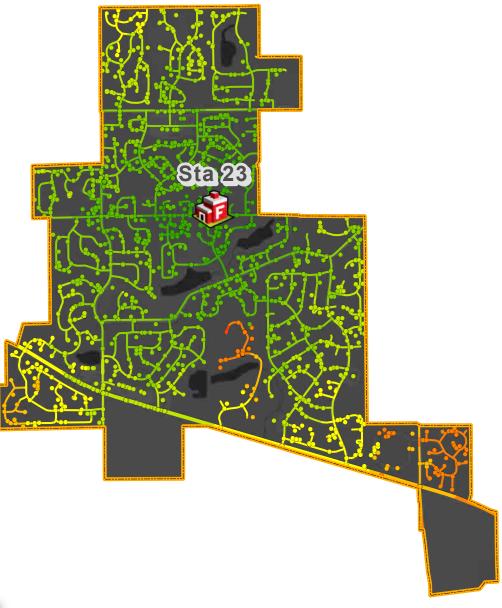
Incidents and streets are displayed in one-minute increments based on travel time from the closest fire station.

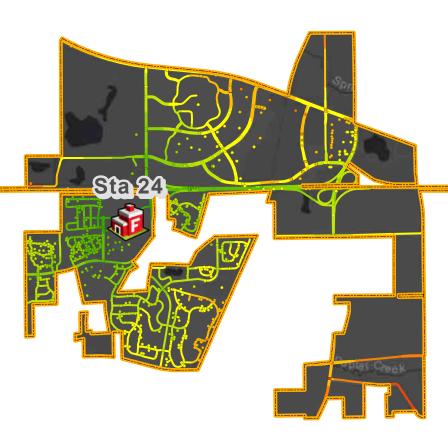
Incidents and streets are displayed in one-minute increments based on travel time from the closest fire station.

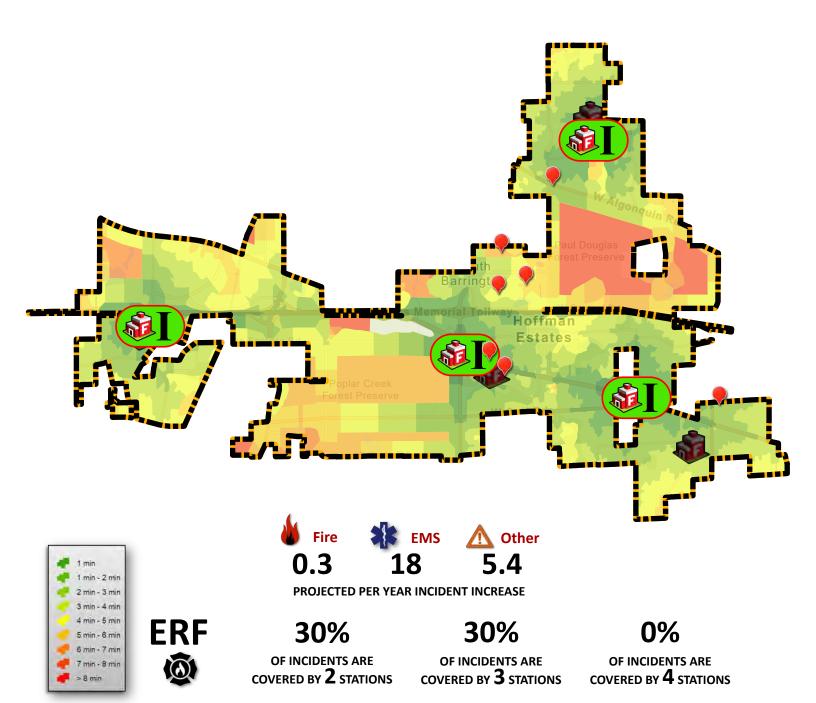
#### **Ideal Station Location:**

The Ideal Station Location was calculated using ESRI's Location - Allocation Analysis tool. 640 possible fire station sites were used with a 4 minute drive time as the cutoff to reach as many incidents as possible.

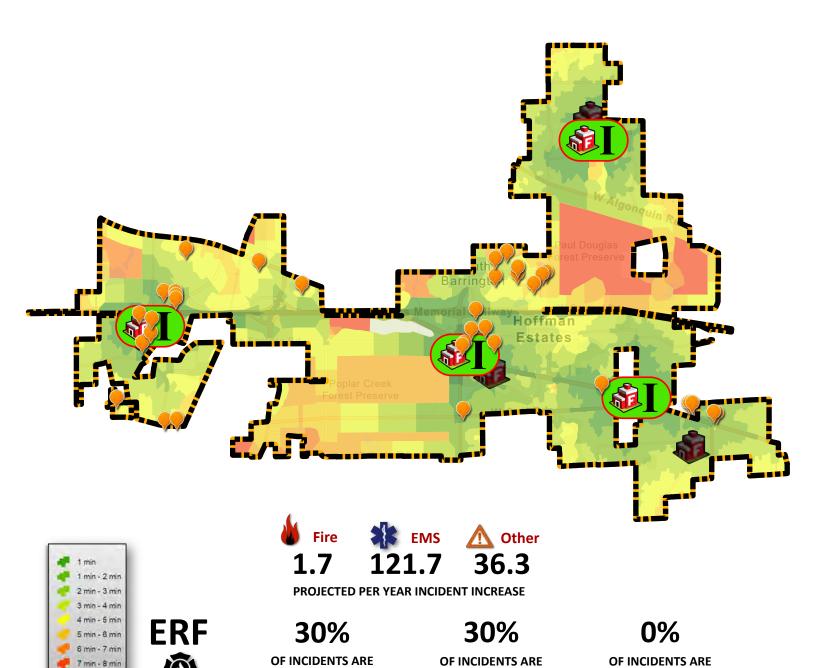
640 possible sites.

The Ideal Station Location was calculated using ESRI's Location - Allocation Analysis tool. 640 possible fire station sites were used with a 4 minute drive time as the cutoff to reach as many incidents as possible.

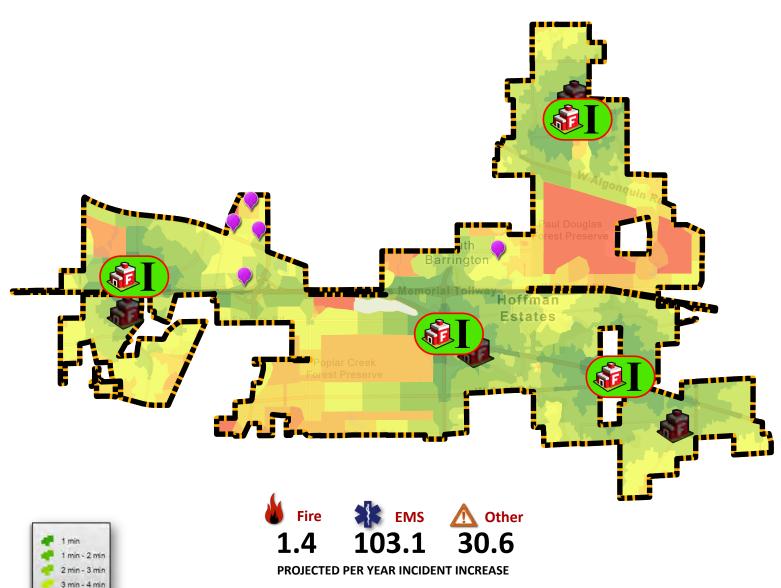
640 possible sites.

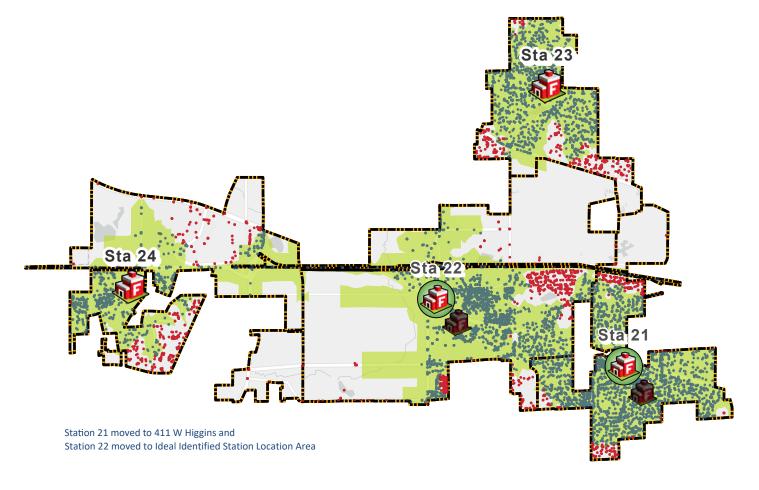
Station 21 moved to 411 w Higgins and Station 22 moved to Ideal Identified Station Location Area
